Manhole Inspection Summary

Manhole # S53K__025MH

Location Address: **734 S Robinson St**

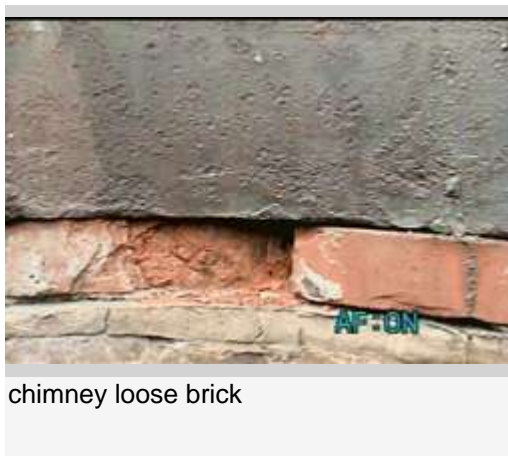
Defect 3

Condition: ☐ Sound ☐ Cracked ☐ Root Intrusion ☒ **Loose Brick** ☐ Deteriorated

chimney loose brick

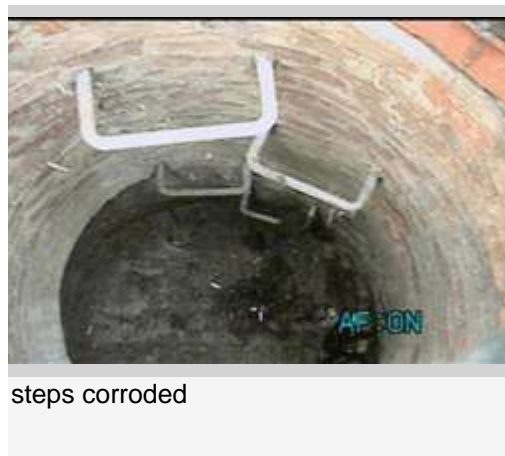
Defect 2

Steps Count: **4** Missing: **0** ☒ **Corroded**

steps corroded

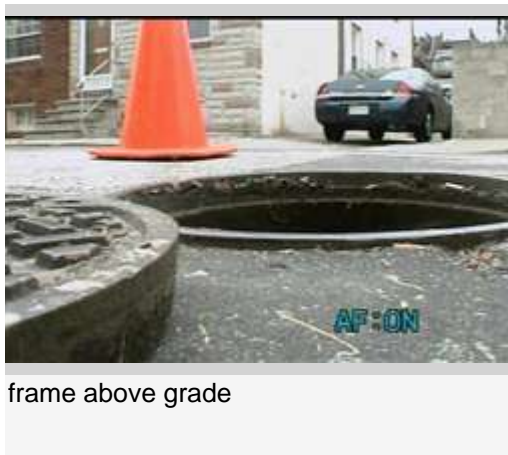
Defect 1

Cover Shape: **Circular** Diameter: **25** (in.) Length: **0** (in.) Dist A/B Grade: **1** (in.)

frame above grade

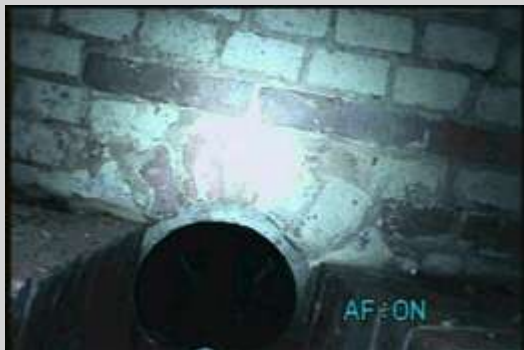
12 O'Clock Outflow

8 in. Circular Gravity Sewer
Pipe Out @ 12 O'Clock

Pipe Material: **Clay** ☐ Pipe Lined

Invert Depth: 7.92 (ft.) Flow Characteristics: **Fast**

Infiltration: **None** Pipe Seal Cond: **Unknown**

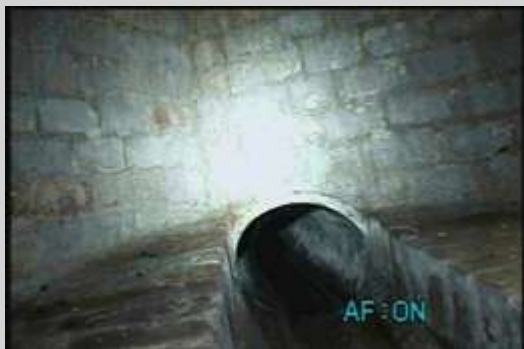
5 O'Clock Inflow

8 in. Circular Gravity Sewer
Pipe In @ 5 O'Clock

Pipe Material: **Clay** ☐ Pipe Lined

Invert Depth: 7.88 (ft.) Flow Characteristics: **Fast**

Infiltration: **None** Pipe Seal Cond: **Unknown**
